# Башта биро, Београд

Београд, 2020.

# ХОТЕЛ МОНА - Београд

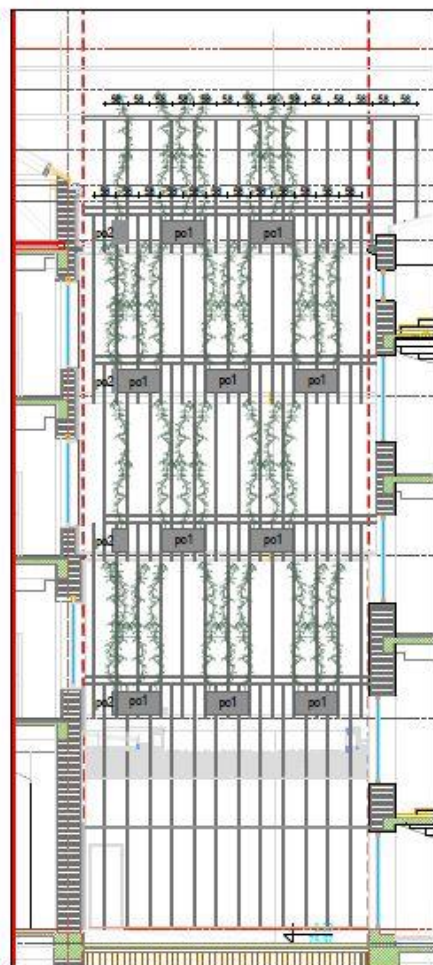
IZGLED S PREDIA  
FRONT VIEW

## KONSTRUKCIJA "ZELENOG ZIDA" CONSTRUCTION "GREEN WALL"

R 1:100

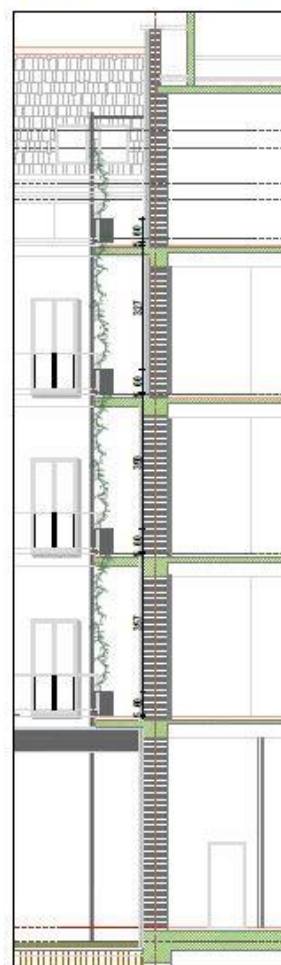
IZGLED SA STRANE  
SIDE VIEW

R 1:100

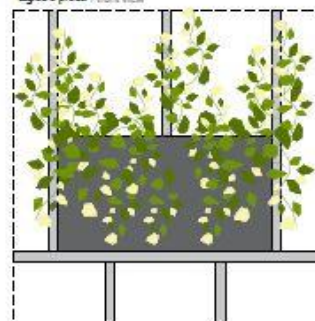
Izgled s predia / front view

TIPSKI PRIKAZ LIMENIH  
ŽARDINJERA p01, p02 i p03  
Osnova  
base

### OPIS ŽARDINJERA

Žardinjere od savijenog i  
varenog pocinkovanog lima  
leže se na horizontalnu  
konstrukciju.  
Kroz kutijaste profile prolaze  
cevi za navodnjavanje i  
odvodnjavanje viška.

DESCRIPTION  
Plant pots of bent and welded  
galvanized sheet metal.  
Montage on horizontal metal  
bars  
Drainage and irrigation pipes  
pass through verticals.
